# National Naval Medical Center Master Plan Update 2008

Appendix - Existing Building Assessments

Bethesda, Maryland

8 AUGUST 2008

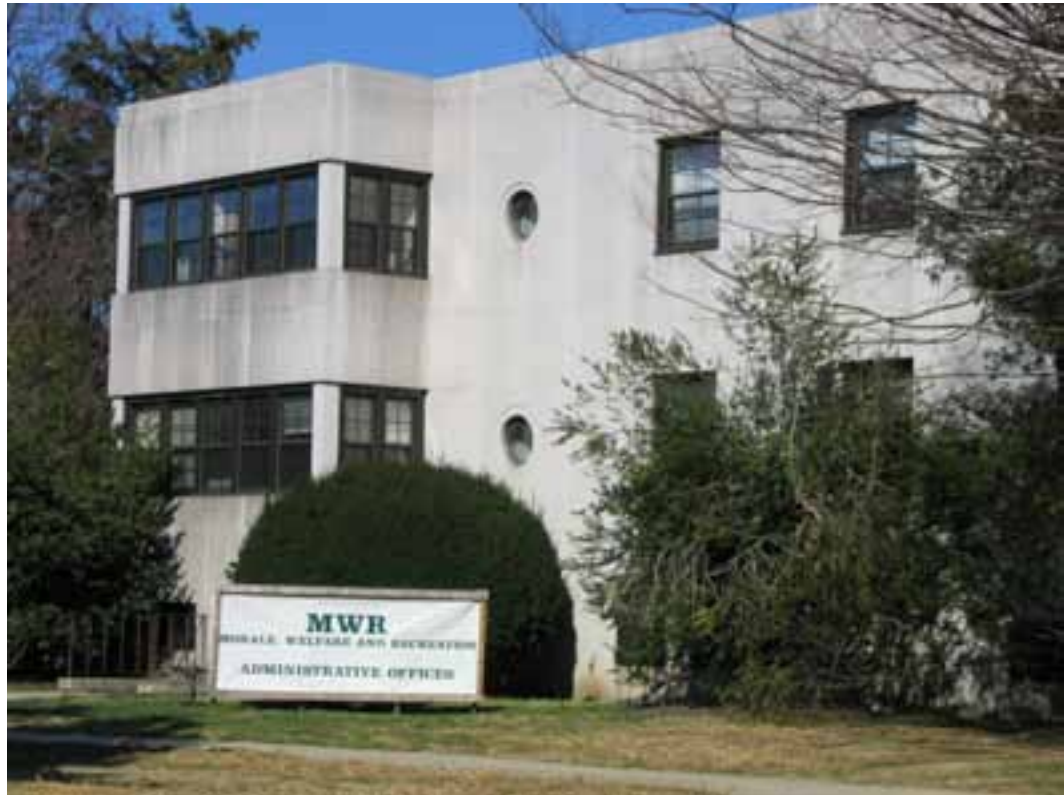
## Building 11 – Administration

**Building 11 Overall Building Condition** *General Condition D*

**Exterior C (Fair)** – The exterior of Building 11 is in fair condition as above grade precast panels are not showing signs of significant deterioration however below grade, the basement walls are in poor condition as indicated by the moisture infiltration resulting in peeling paint on the interior of the exterior walls.

**Interior D (Poor)** – The interior of Building 11 is in a variety of different conditions from fair to poor. In the vacant areas, the condition is poor as no renovation has occurred in these areas for some time. Remainder of the areas is fair but the finishes are worn from the building function use.

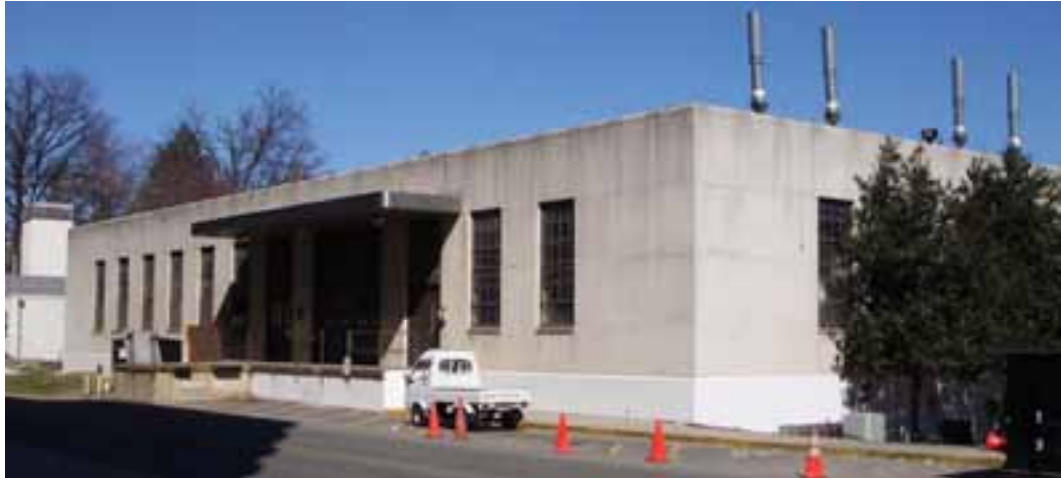
## Building 13 – Receiving / Storage

***Building 13 Overall Building Condition***

**Exterior B (Good)** – Similar to other campus buildings of the same age, the exterior condition of Building 13 is in good condition except for some minor cracking in the precast panels. From adjacent structures the roof system visually appears to be fairly new.

**Interior C (Fair)** – The interior condition of Building 13 is, overall, in fair condition due to the abuse of the building function. Some cracking in the concrete floors was noted. The finishes appeared to not have been updated since the last building renovation.

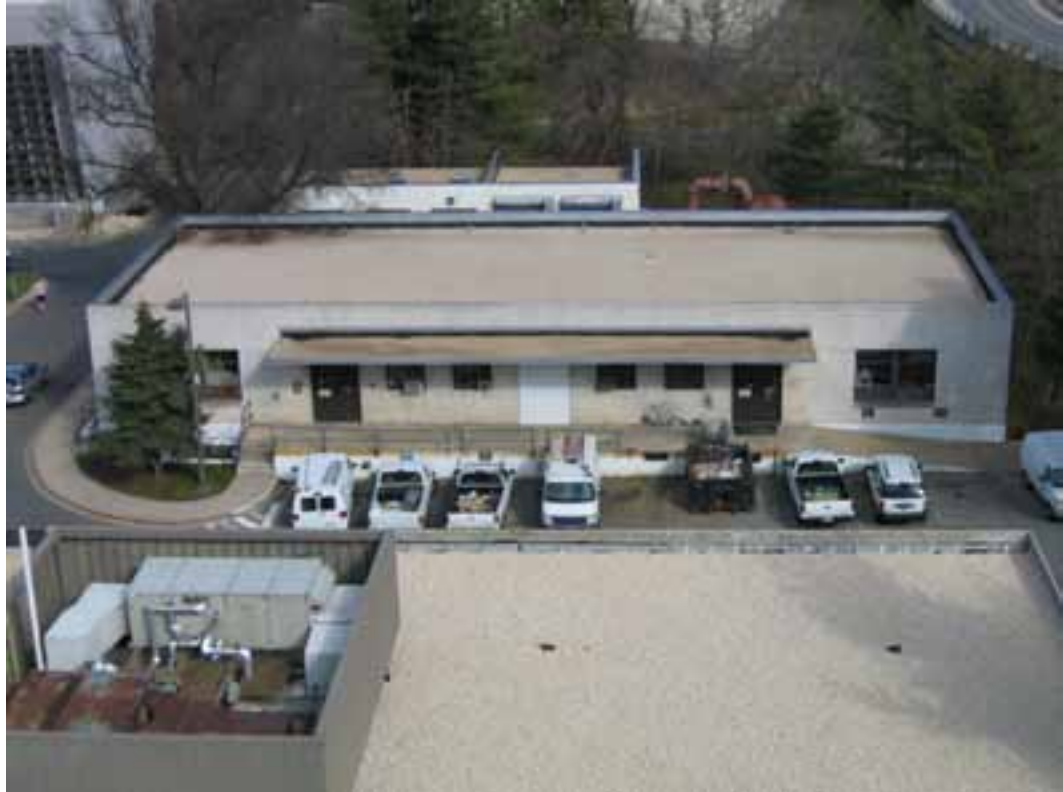
## Building 15 – Shops

***Building 15 Overall Building Condition***

**Exterior B (Good)** – Similar to other buildings constructed on NNMC campus within the same time frame, the condition of the exterior of Building 15 is in good condition with no visible deterioration of the precast panels and only slight deterioration of the existing steel framed and glass awning windows. Review of the roof system from adjacent structures revealed the roof was not new but may have been new within the last 10 years.

**Interior C (Fair)** – Similar to other facility maintenance buildings clustered around the Utility Plant, Building 15, has not received recent renovations, therefore, it is in fair condition. Many of the existing materials are durable and have held up well.

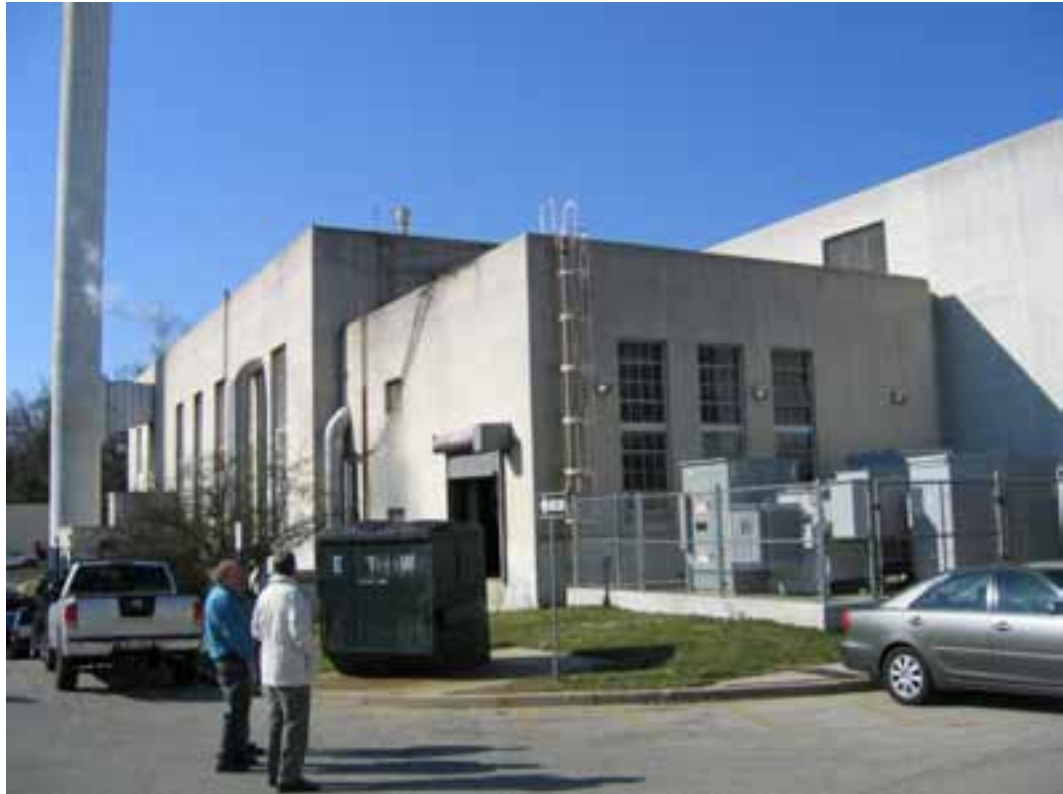
## Building 16 – Utility Plant

***Building 16 Overall Building Condition***

To upgrade the Building 16, an inventory of the existing equipment should be performed to determine the life cycle of the equipment and some minor refurbishment performed to update the dated areas.

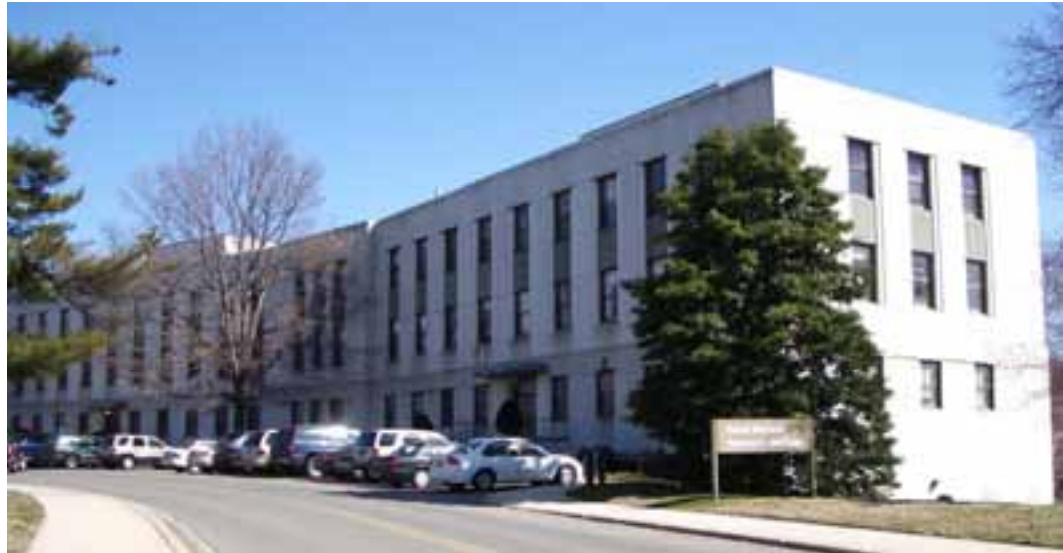
## Building 17 – Vacant

**Interior E (Unacceptable)** – The condition of the interior of Building 17 is in unacceptable condition because it remains as is since previously occupied. Partitions appear to be original construction of plaster on wood studs with little renovation. Ceilings are sagging from no humidity control and some ceilings as well as walls are showing signs of what could be characterized as mold. In addition, there is a significant amount of asbestos as evidenced in the vast number of reports in NNMC records contained in various materials inside the building requiring abatement before any renovation to the building.

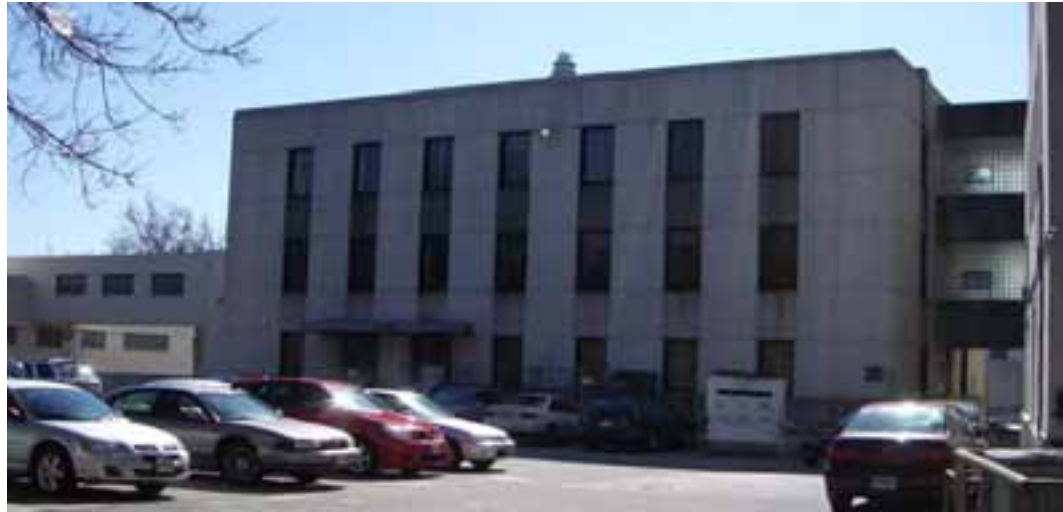
## Building 18 – Vacant

**Interior E (Unacceptable)** – The condition of the interior of Building 18 is in unacceptable condition because the building remains as it has since previously occupied. Partitions appear to be mostly original construction of plaster on wood studs with some new partitions from previous renovation. There is also a significant amount of asbestos contained in various materials inside the building requiring abatement before any renovation to the building.

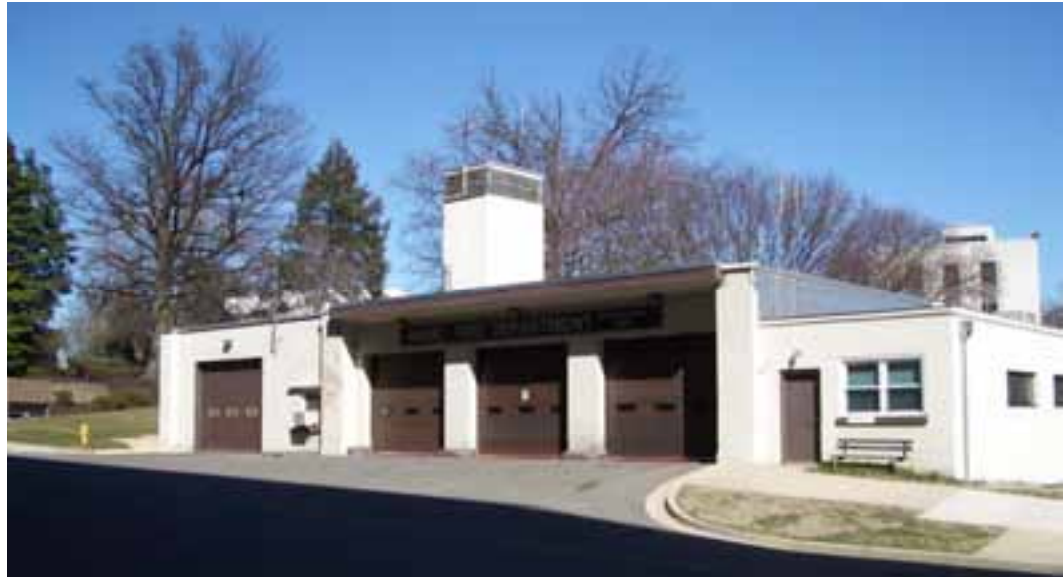
## Building 20 – Firehouse

**Interior C (Fair)** – The condition of the interior of Building 20 is in a variety of conditions from good to fair depending on which parts of the building are being evaluated. In the older parts of the building, the materials are dated and could be updated. However, in the new addition the finishes are much newer and in better shape.

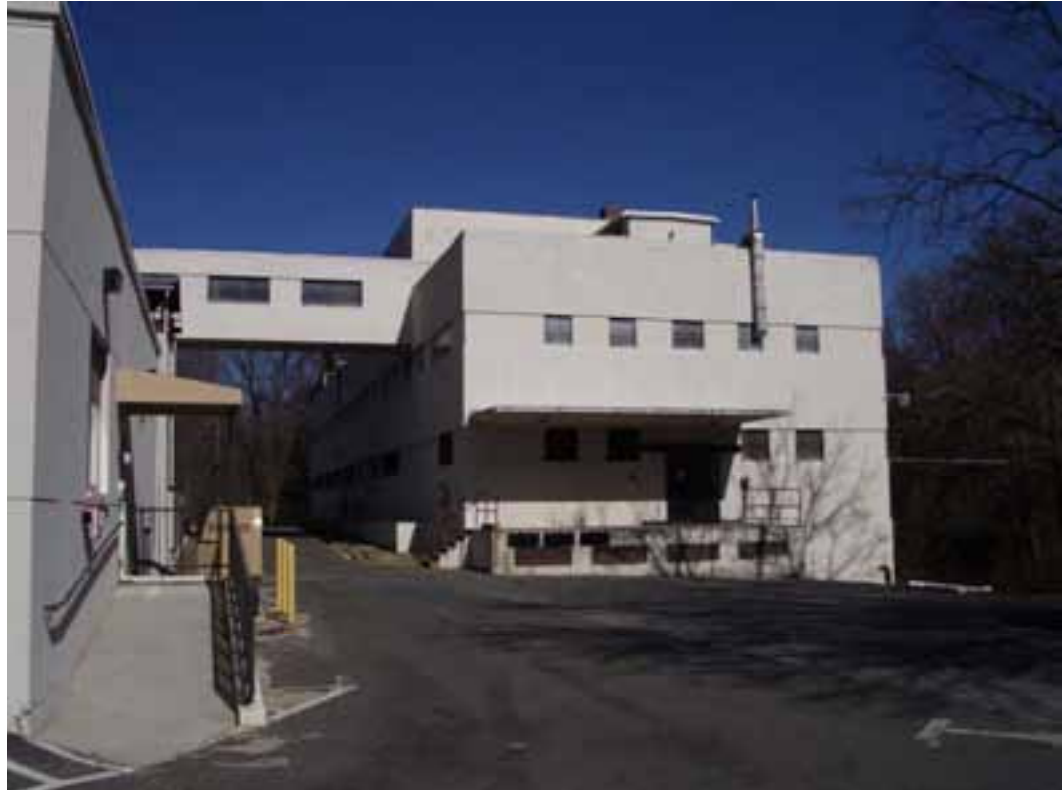
## Building 21 – Vacant

**Interior C/D (Fair/Poor)** – The condition of the interior of Building 21 is in fair/poor condition because the building has remained vacant for many years. The organization of Building 21 was originally designed to accommodate animal storage and would be difficult to renovate to another function without significant cost. All partitions visually appear to be original construction with no renovation. Similar to Building 17 and Building 18, ceilings are sagging from no humidity control and some ceilings as well as walls are showing signs of what could be characterized as mold. There is also a significant amount of asbestos within existing building materials requiring abatement before renovation.

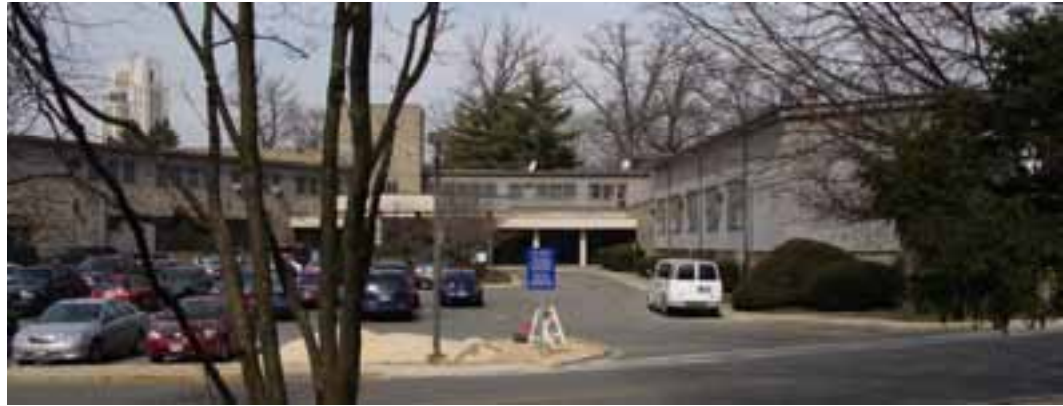
## Building 23 – Gym / Fitness Center/ Pool

which may have some historical significance, and has spaces such as the gym and pool that have nice character, it would require a significant amount of cost to upgrade the existing building.

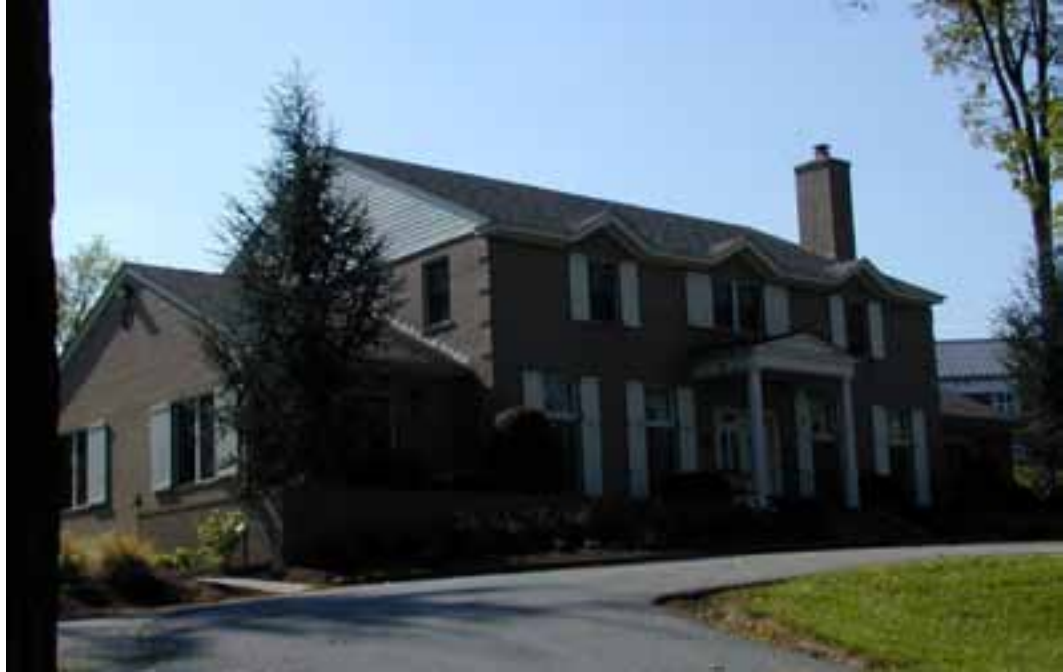
## Building 24, Building 25 – Fisher Houses

**Interior A (Excellent)** – The interior of Building 24 and Building 25 is in excellent condition. Existing finishes are in good shape and well maintained.

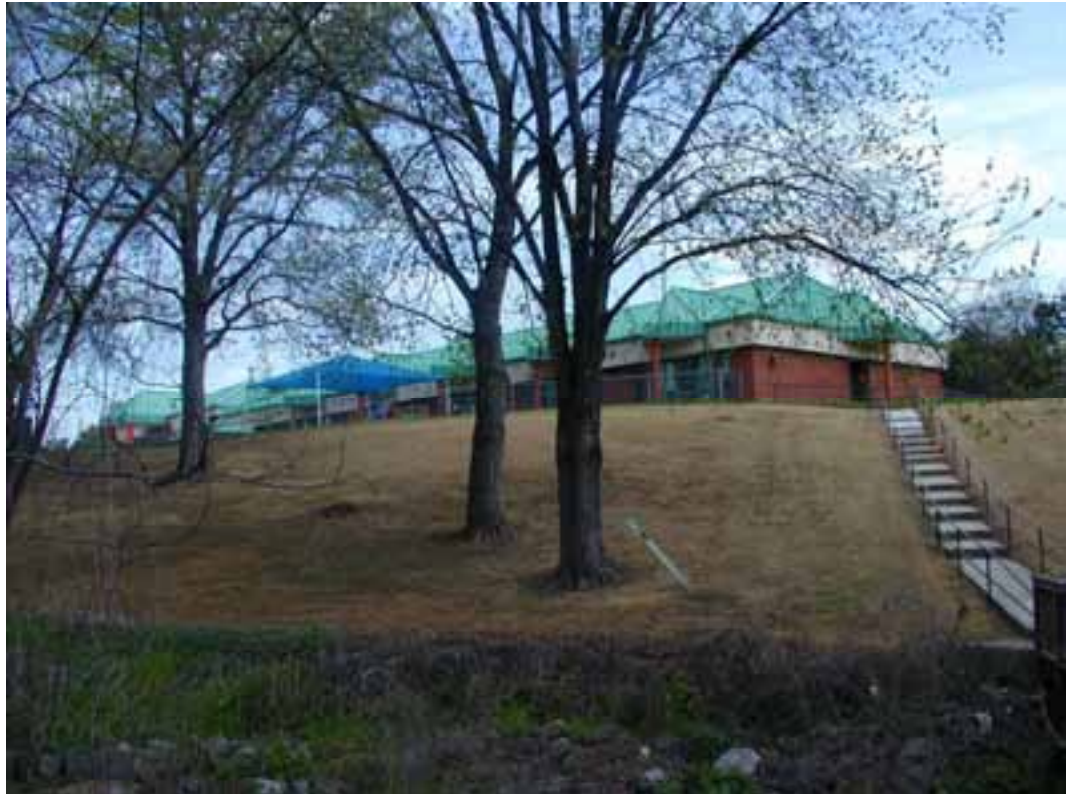
## Building 26 – Child Development Center

**Interior A (Excellent)** – The interior of Building 26 is considered to be in excellent condition. Although it is over 10 years old, it is well maintained and appears to be in very good condition.

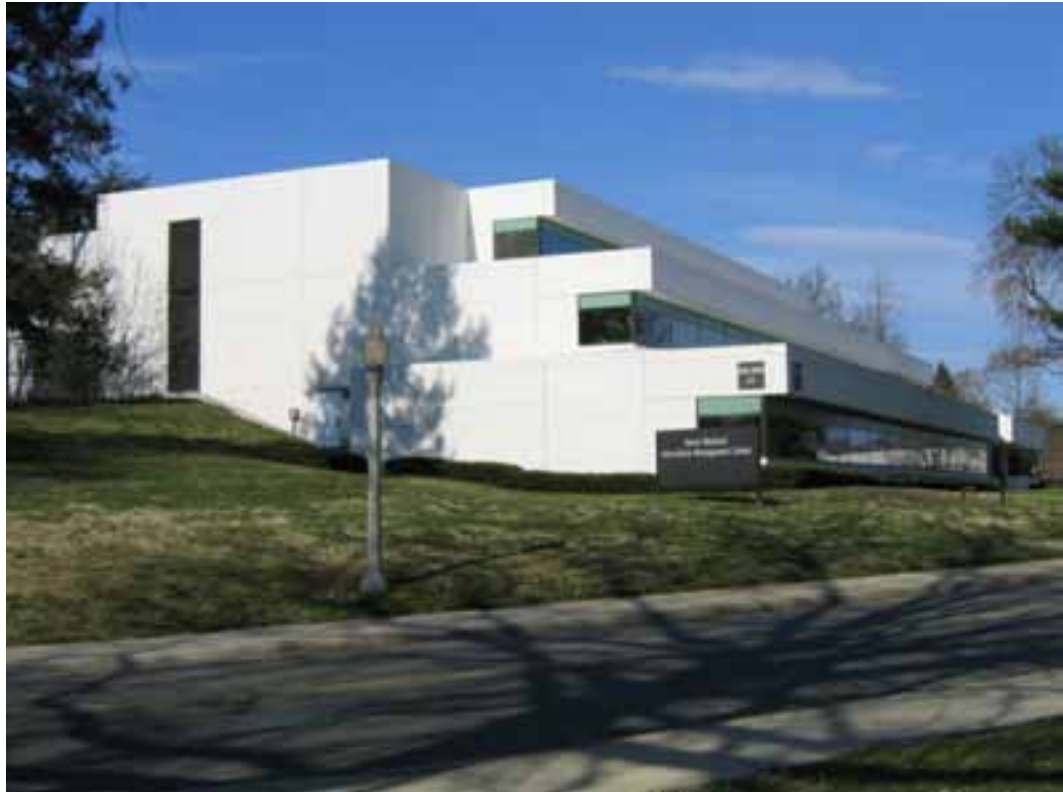
## Building 27 – Medical Information Management Center

**Interior B (Good)** – The interior of Building 27 is in good condition. Finishes visually appear to be in good condition and well maintained.

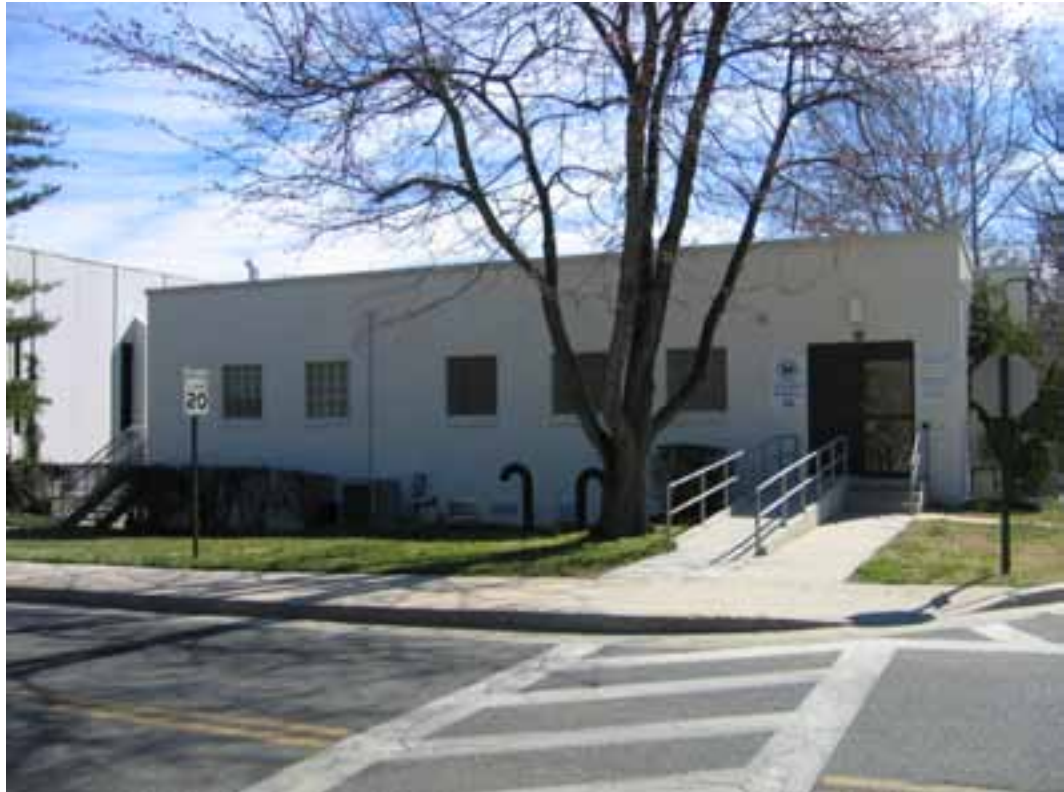
## Building 28 – Administration (USUHS)

**Interior A/B (Excellent/Good)** – The interior of Building 28 is in good condition. Although NNMC records indicate the space to be substandard, the facility was recently renovated and in good condition.
